# **Geology and Preliminary Hydrogeologic Characterization of the Cell-House Site, Berlin, New Hampshire, 2003-04**

Scientific Investigations Report 2004-5282

**U.S. Department of the Interior  
U.S. Geological Survey**

By James R. Degnan, Stewart F. Clark, Jr., Philip T. Harte, and Thomas J. Mack

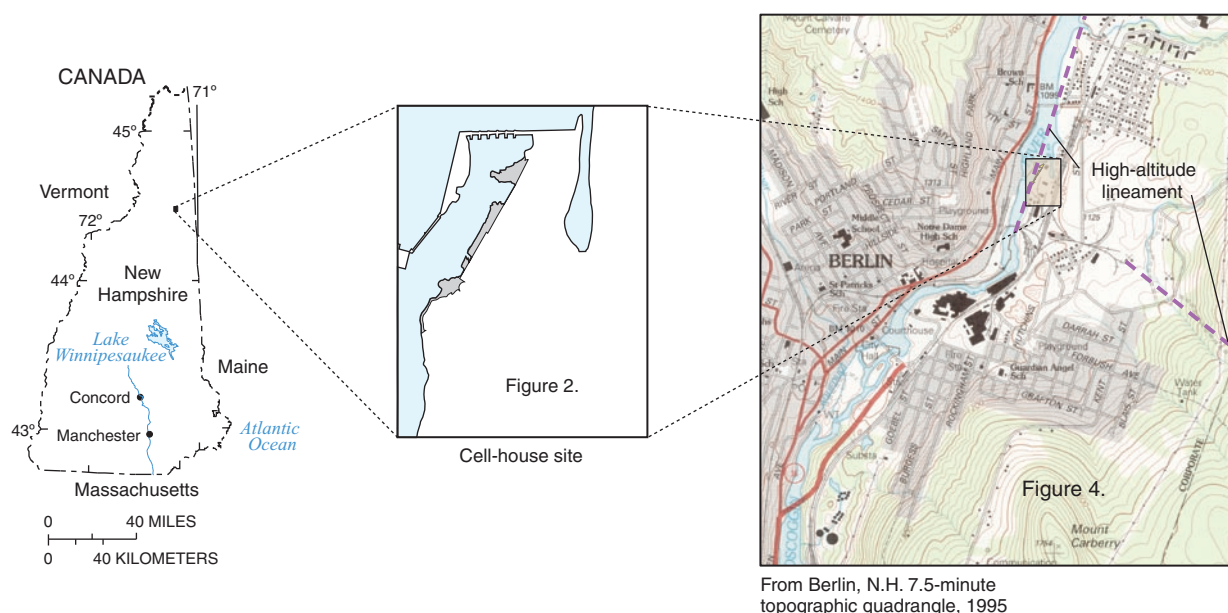
**Figure 1.** Location of the study area, Berlin, N.H., with lineaments from high-altitude photography. (Lineaments from Ferguson and others, 1999).

Two lineaments (fig. 1) identified from high-altitude areal photographs pass near the cell-house site along the riverbank, and towards the southern end of the site (Ferguson and others, 1999). Certain types of lineaments, particularly certain fracture-correlated lineaments, have been associated with more transmissive bedrock in New Hampshire (Moore and others, 2002).

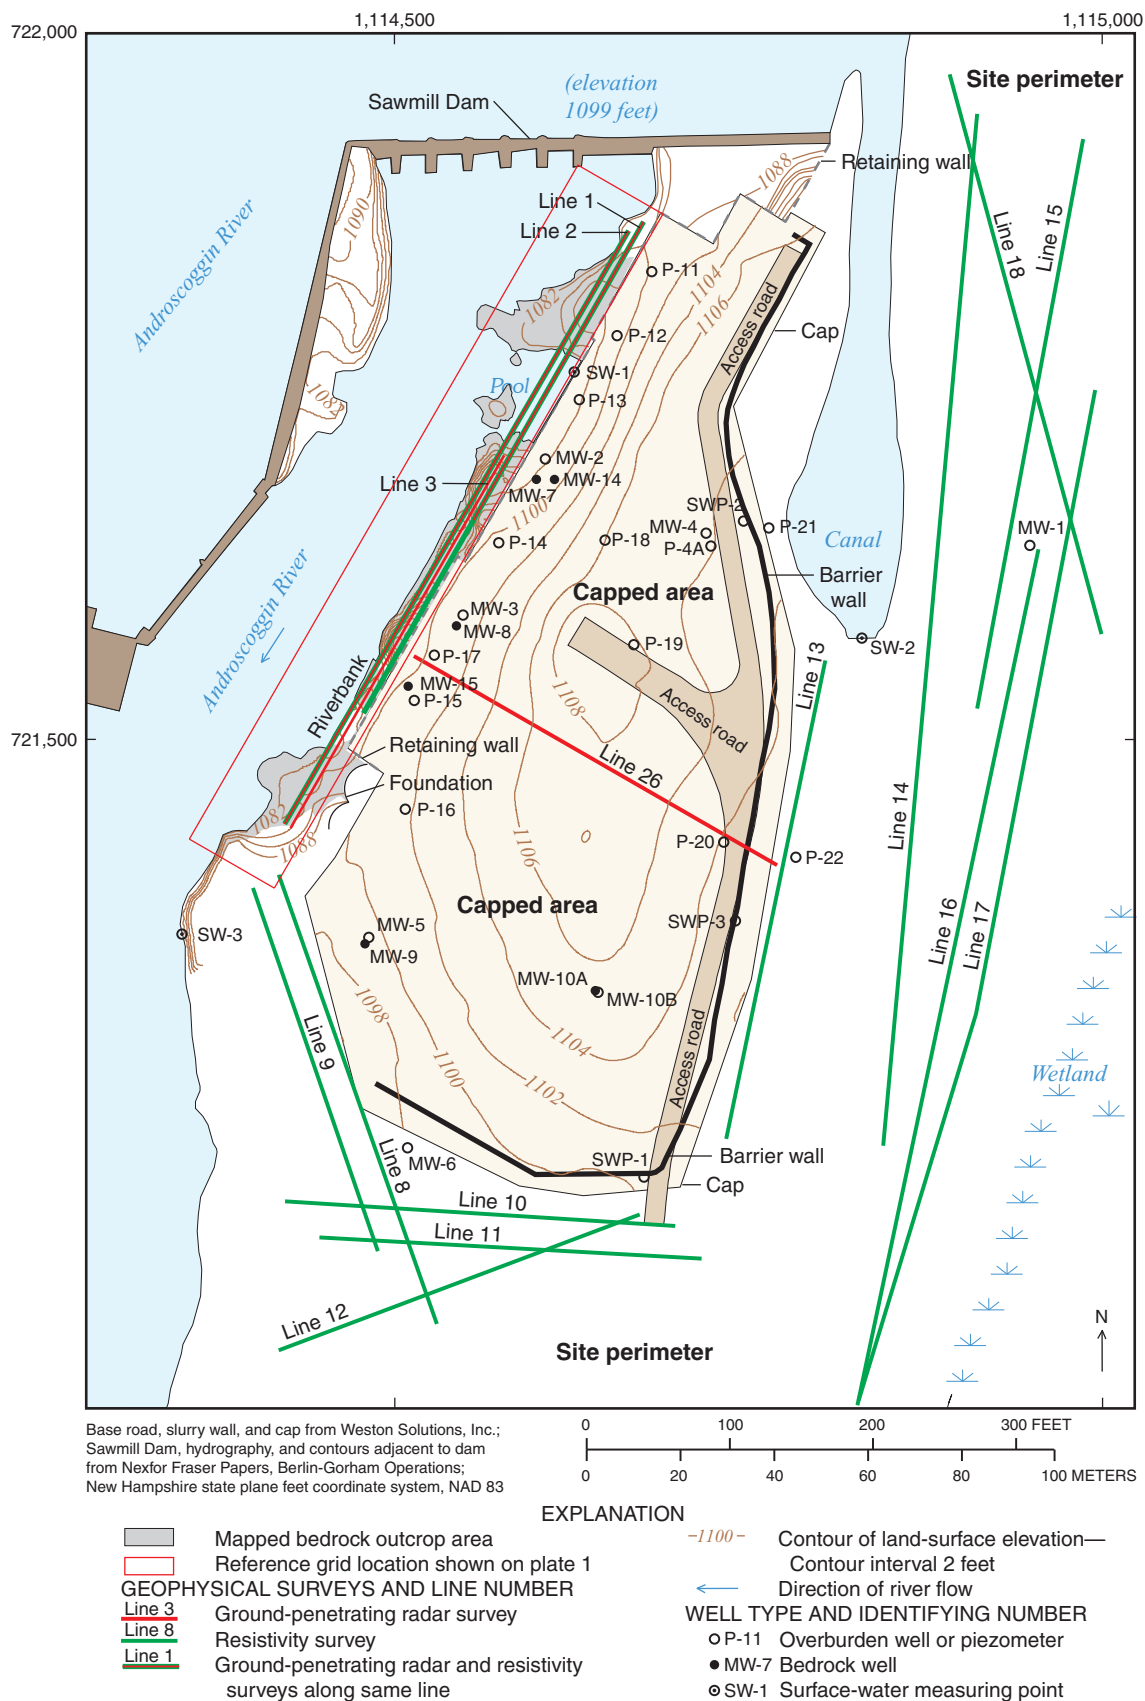
**Figure 2.** Location of reference grid, geophysical survey lines, mapped bedrock area, and water-level monitoring points at the cell-house site, Berlin, N.H.

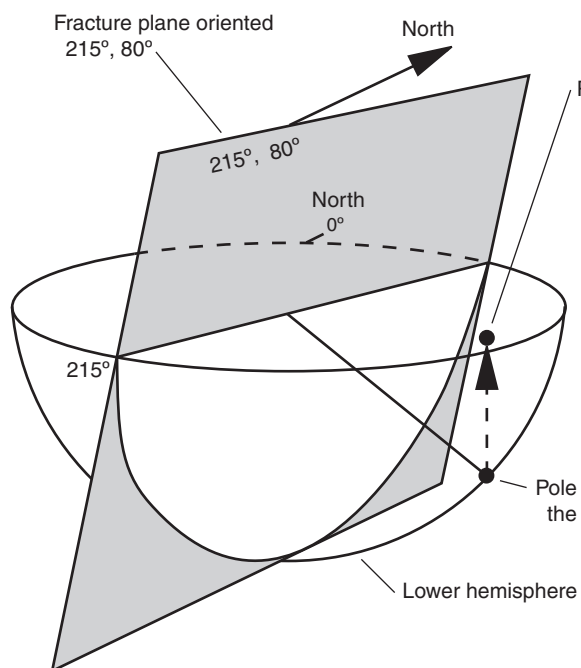
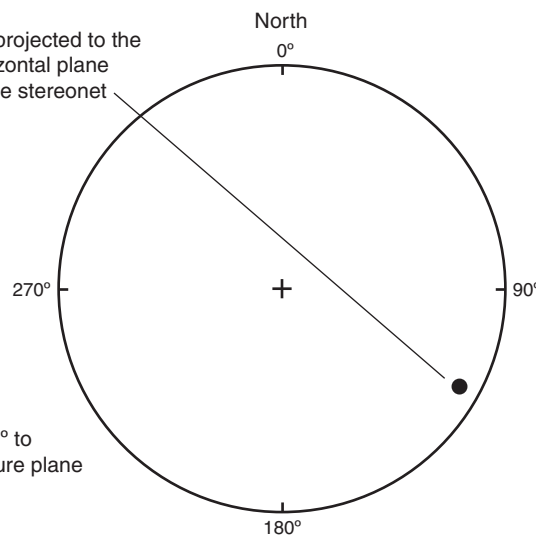
**A. Three-dimensional fracture plane intersecting the lower hemisphere and the projected pole to the plane**

**B. Stereonet of A**

**Figure 3.** Schematic diagram of lower hemisphere stereonet projections. The stereonet projection reduces the orientation of a fracture plane to a point on a stereonet by plotting the pole to the plane on a lower hemisphere and projecting it up to the horizontal plotting surface of the diagram. The schematic (A) shows a three-dimensional representation of the fracture plane as it intersects the hemisphere and the projected pole to a plane that strikes  $215^\circ$  and dips  $80^\circ$ , and (B) shows the stereonet that would correspond to example (A). (Modified from Johnson and others, 1999.)

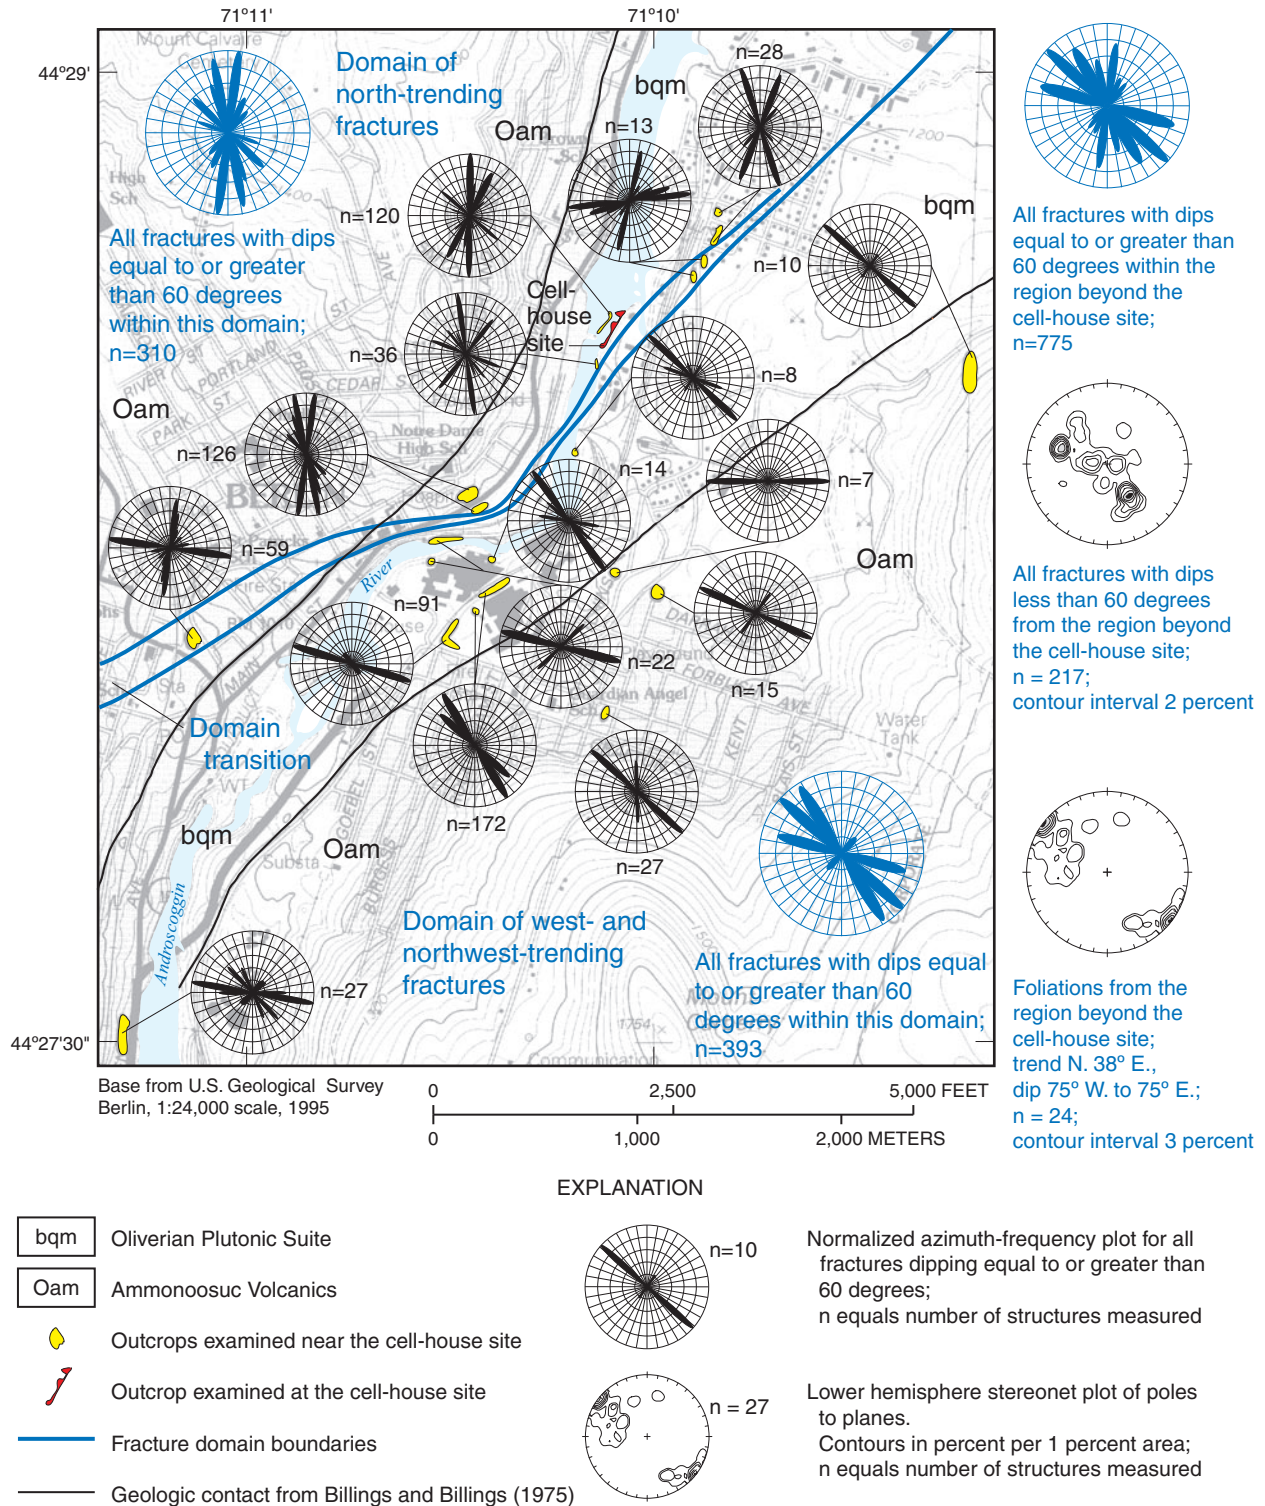
**Figure 4.** Bedrock geology, azimuth-frequency plots of fractures, fracture domains, and foliation near the cell-house site, Berlin, N.H.

Examination of 20 outcrops within a 1-mi radius of the cell-house site (fig. 4) support the division of units presented by Billings and Billings (1975). The narrow belt of rocks trending north-northeast through Berlin is dominated by Oliverian Plutonic Suite lithologies. Amphibolites of the Ammonoosuc Volcanics, believed to be xenoliths, are found within the area mapped as Oliverian Plutonic Suite rocks. For example, amphibolite (dark green to black, fine-needle, hornblende-plagioclase gneiss) xenoliths occur along Route 16, about 1,000 ft north of the hospital shown on the 7.5-minute, Berlin, N.H., topographic map. Dark-gray to black hornblende-biotite gneiss with biotite porphyroblasts also are present in rocks mapped as Oliverian in outcrops east of the entrance to the Berlin pulp mill. Unmetamorphosed lamprophyre dikes contain xenoliths of gray gneiss and pink feldspar-bearing gneiss and occur in outcrops east of the entrance to the Berlin pulp mill (about 1,000 ft south of the cell-house site).

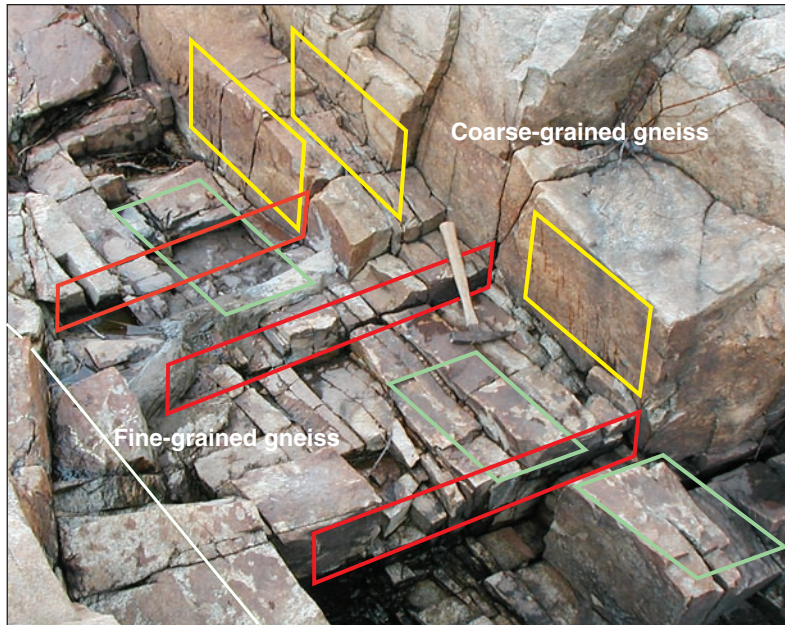
**Figure 5.** Fine-grained gneiss showing three sets of planar, parallel fractures from grid cell B21 (plate 1), view to southwest, at cell-house site, Berlin, N.H. (Planar-fracture sets are shown by three parallel colored rectangles for each set; white line is string tied between bolts marking grid-cell lines; scale shown by hammer near center of photograph.)

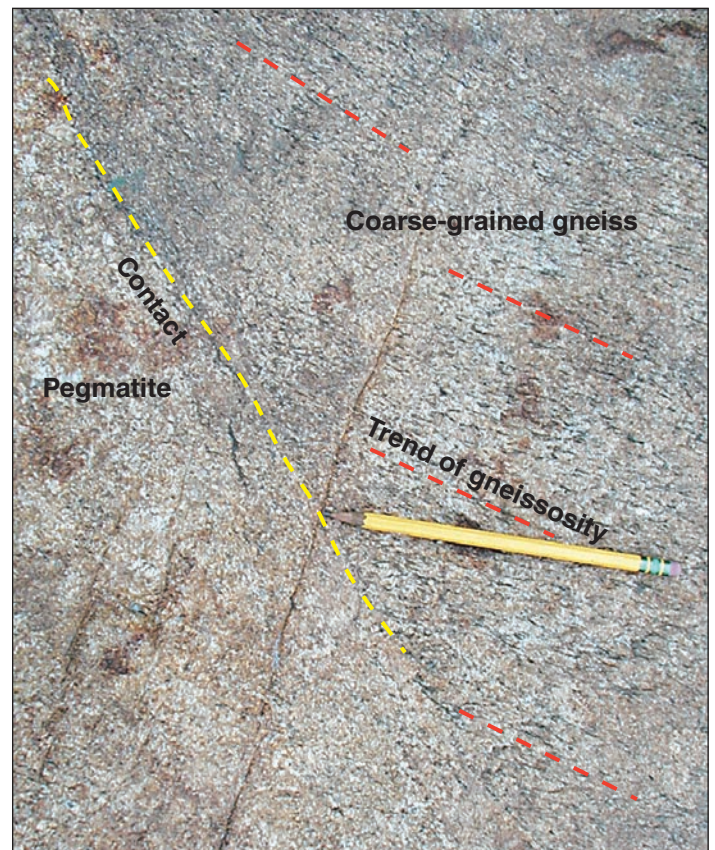
**Figure 6.** Trend of gneissosity in coarse-grained gneiss cut by pegmatite from grid cell B24 (plate 1), cell-house site, Berlin, N.H. (Scale shown by pencil.)

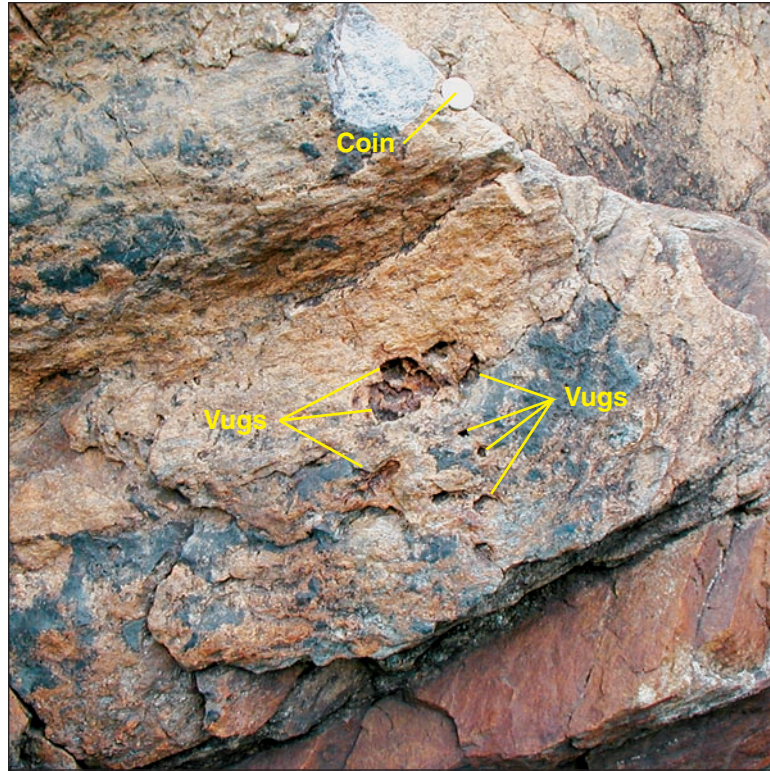
**Figure 7.** Vugs along the margin of chlorite-schist layer on a vertical outcrop face from grid cell B25 (plate 1), cell-house site, Berlin, N.H. (Scale shown by dollar coin.)

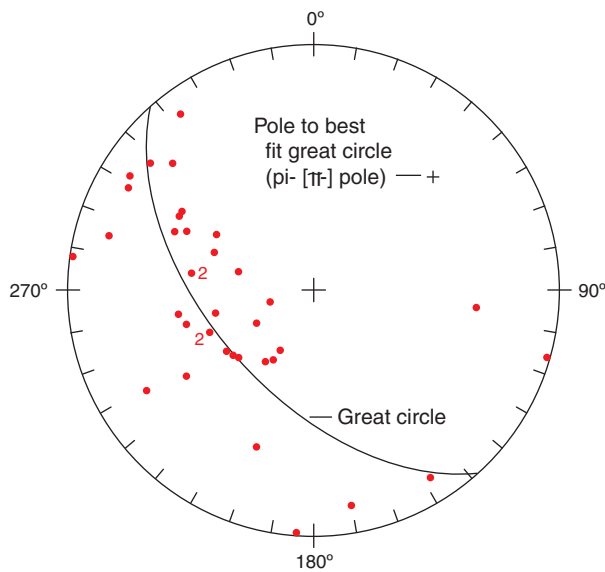
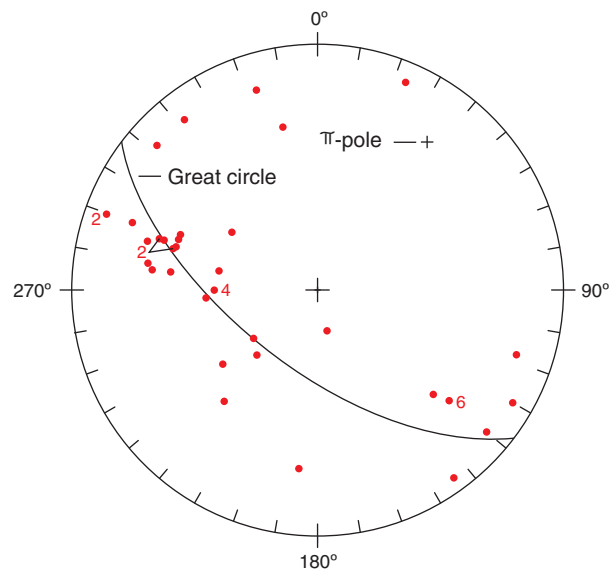
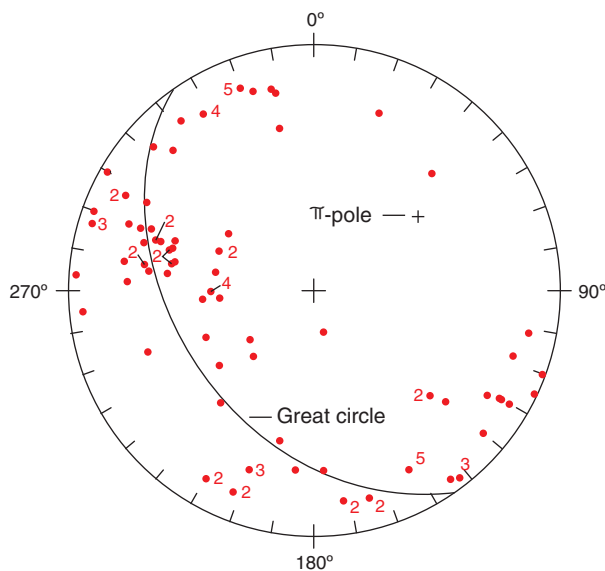
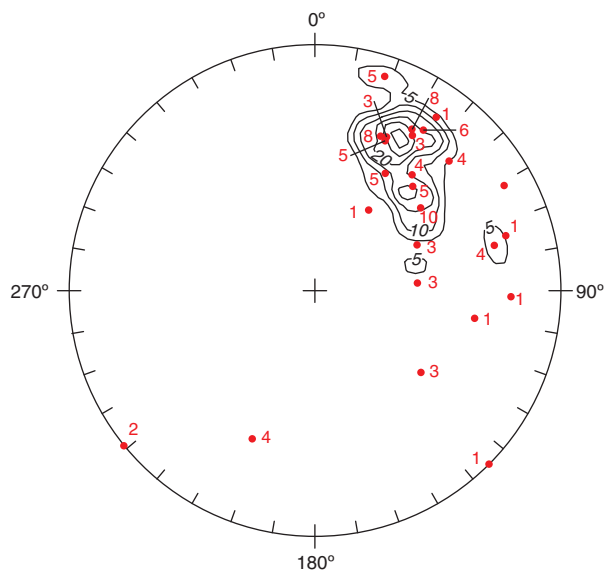
Best fit great circle defines fold axis that plunges  
N. 48° E., 34°.  
Number of measurements, 37.  
Each dot represents 1 unless noted otherwise.

Best fit great circle defines fold axis that plunges  
N. 37° E., 26°.  
Number of measurements, 44.  
Each dot represents 1 unless noted otherwise.

Best fit great circle defines fold axis that plunges  
N. 55° E., 47°.  
Number of measurements, 100.  
Each dot represents 1 unless noted otherwise.

Maximum concentration plunges N. 29° E., 30°.  
Number of measurements, 92.  
Contour interval is 5 percent; maximum point is 32 percent.  
Each dot represents 1 unless noted otherwise.

**Figure 8.** Stereonet plots for ductile structures in the bedrock outcrop at the cell-house site, Berlin, N.H., for (A) poles to gneissosity, (B) poles to chlorite-mineralized fractures and chlorite-schist lenses, (C) poles to all non-planar fracture and chlorite-schist lenses, and (D) axes of minor folds, crenulations, and long axes of rods and vugs.

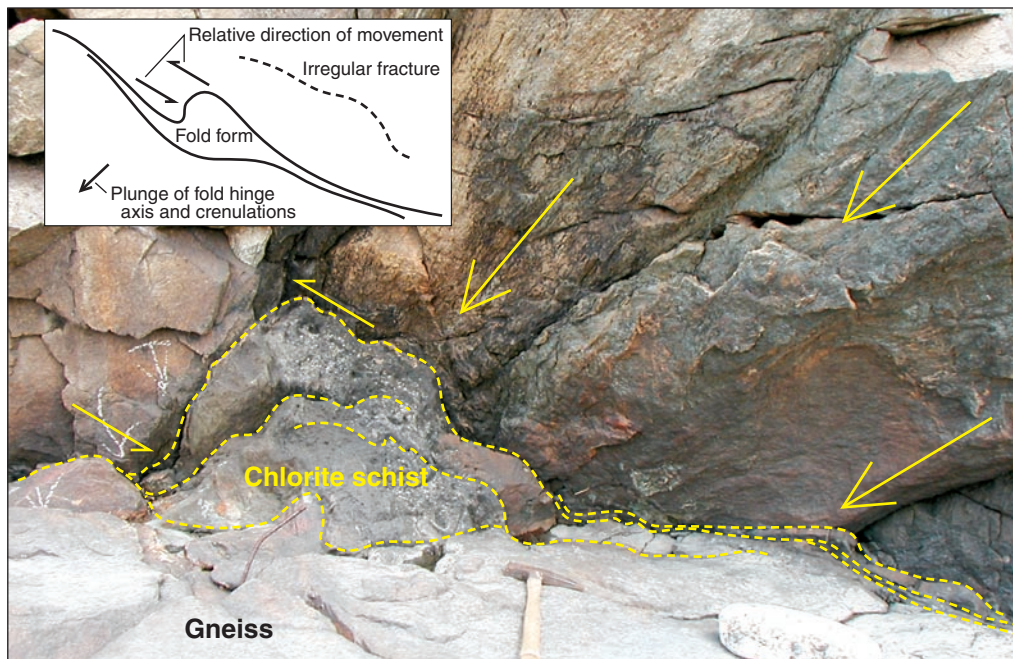
**Figure 9.** Fold hinge in asymmetric F2 fold in chlorite-schist lenses, cross section view to northeast, in grid cell B25 (plate 1), cell-house site, Berlin, N.H. (Scale shown by hammer in the foreground.)

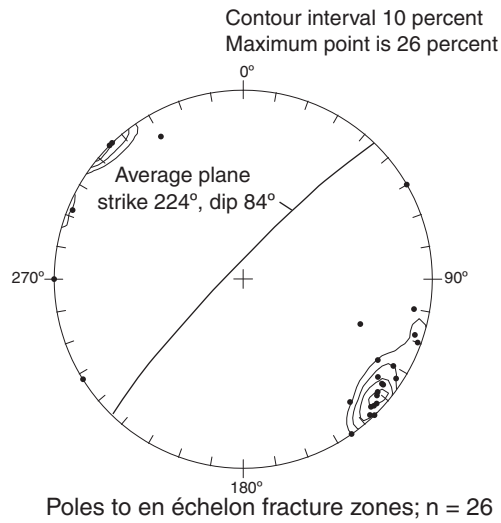
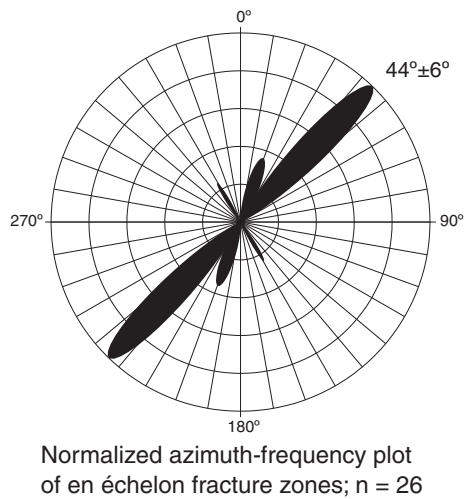
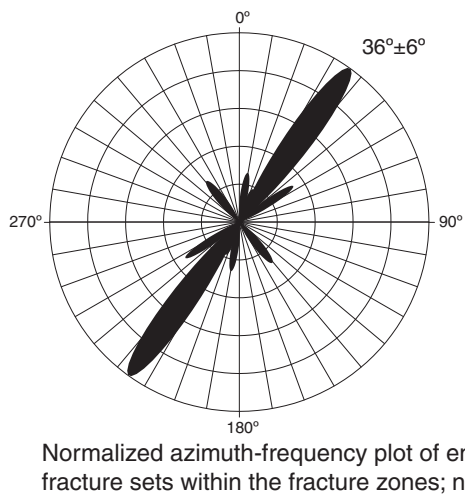
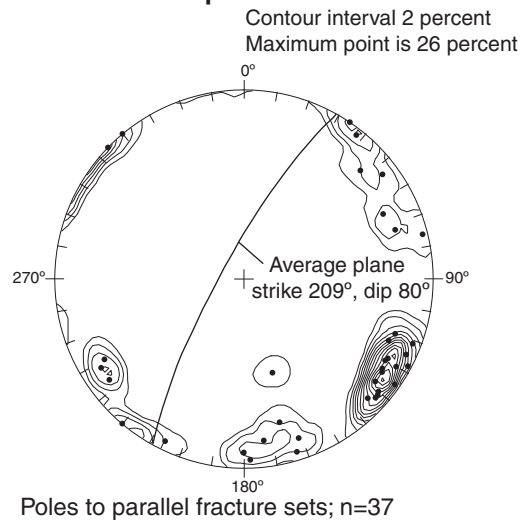
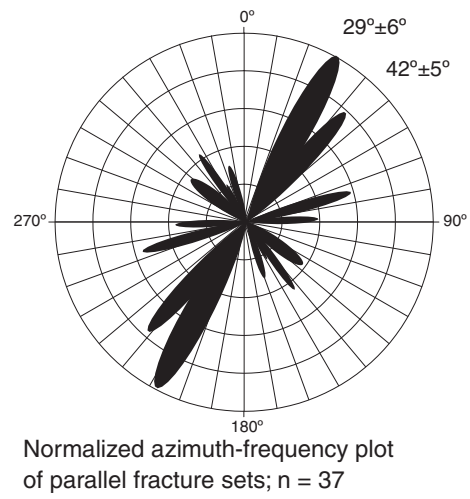
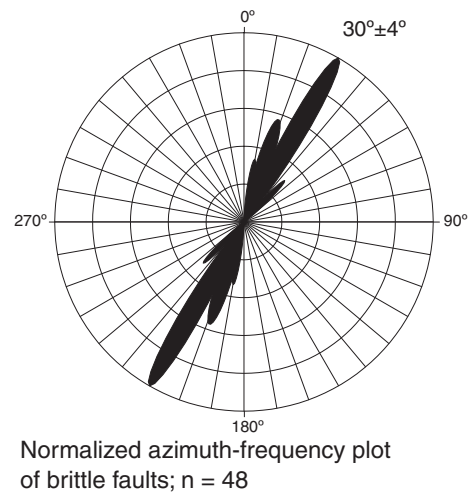
**A. Orientations for en échelon features**

**B. Orientations of parallel fracture sets**

**C. Orientation of brittle faults**

**Figure 10.** Stereonets and azimuth-frequency plots for orientations of planar structures in the bedrock outcrop at the c measurements.)

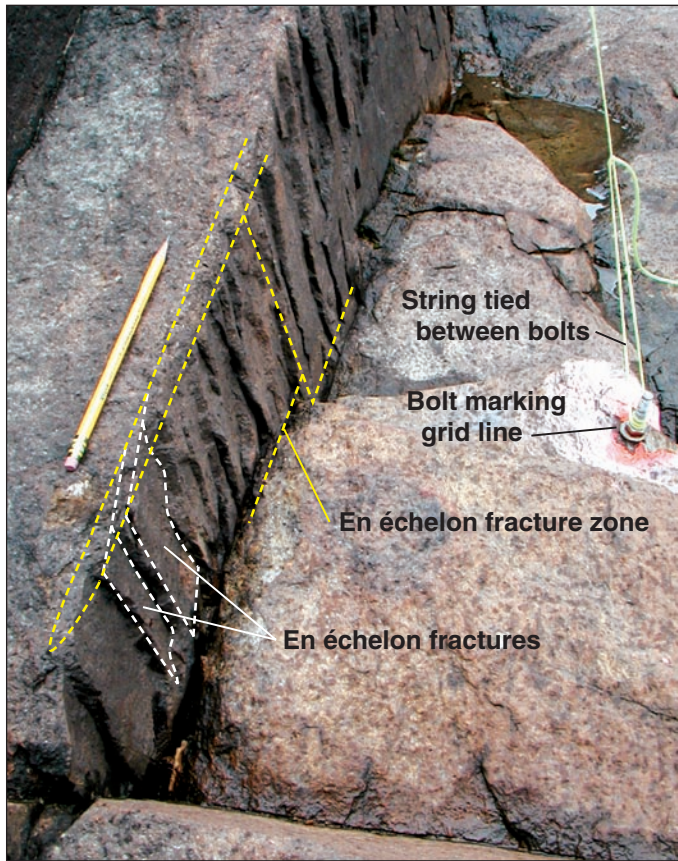
**Figure 11.** Outcrop with en échelon fractures in an en échelon fracture zone, cell-house site, Berlin, N.H. Map view with south at top in grid cell A20 (plate 1). (Scale shown by pencil on the left.)

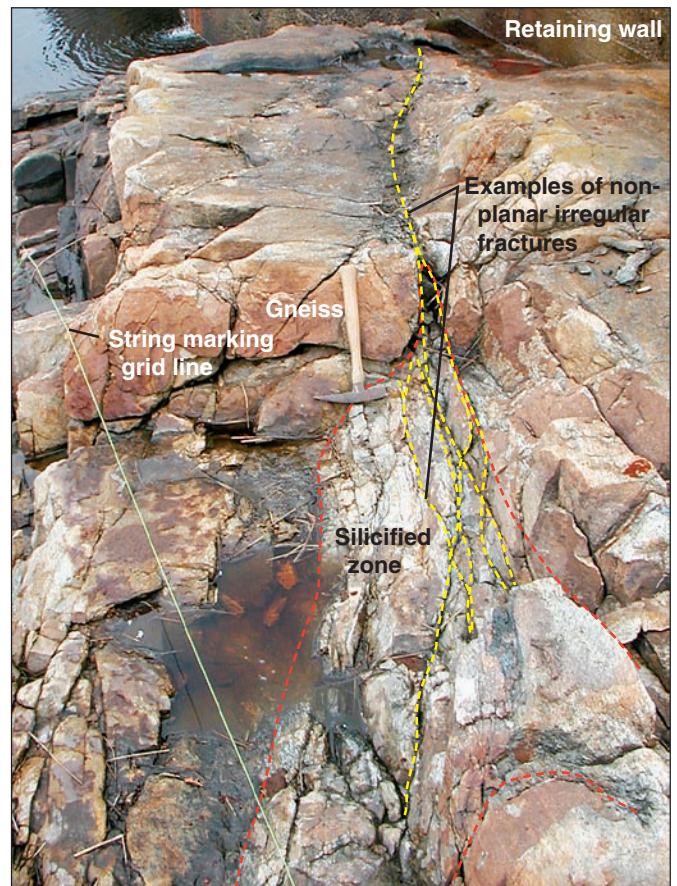
**Figure 12.** Outcrop of silicified fracture zone (boundary shown by red dashed line) and nonplanar irregular fractures and gneiss, cell-house site, Berlin, N.H. View to northeast, in grid cell A22 (plate 1). (Scale shown by hammer near center of photograph.)

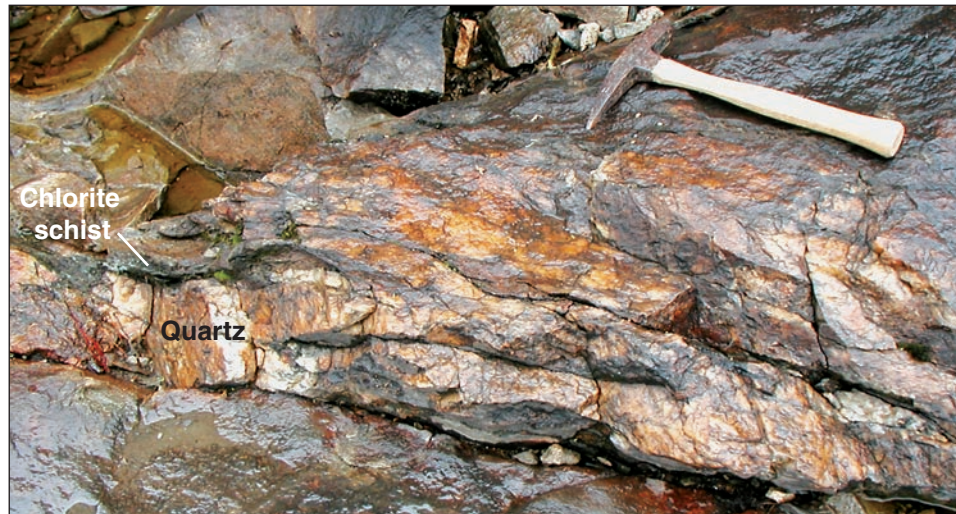
**Figure 13.** Outcrop with multiply sheared quartz containing interleaved chlorite schist, cell-house site, Berlin, N.H. From grid cell B31 (plate 1). (Scale shown by hammer.)

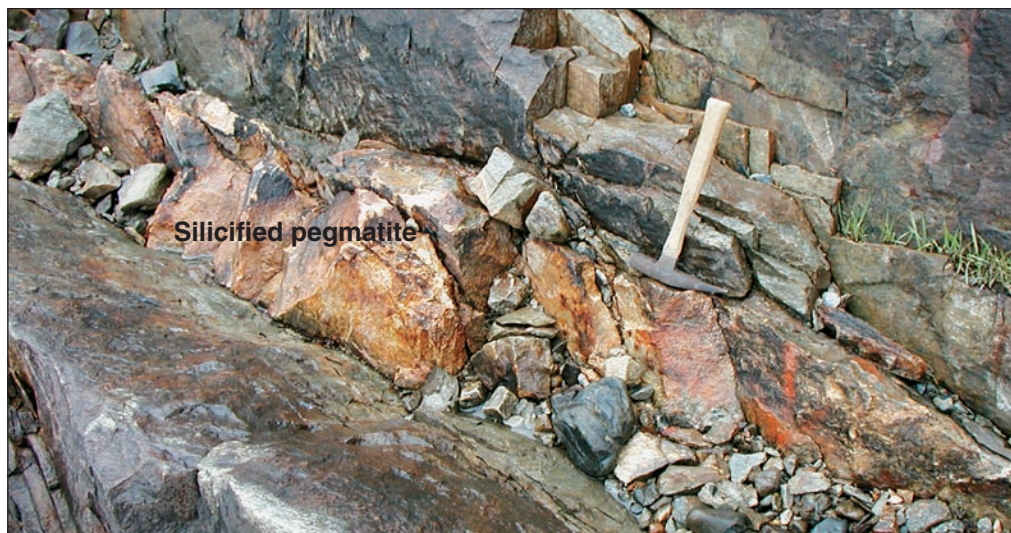
**Figure 14.** Outcrop with fault-bounded silicified pegmatite, cell-house site, Berlin, N.H. From grid cell B28 (plate 1). (Scale shown by hammer.)

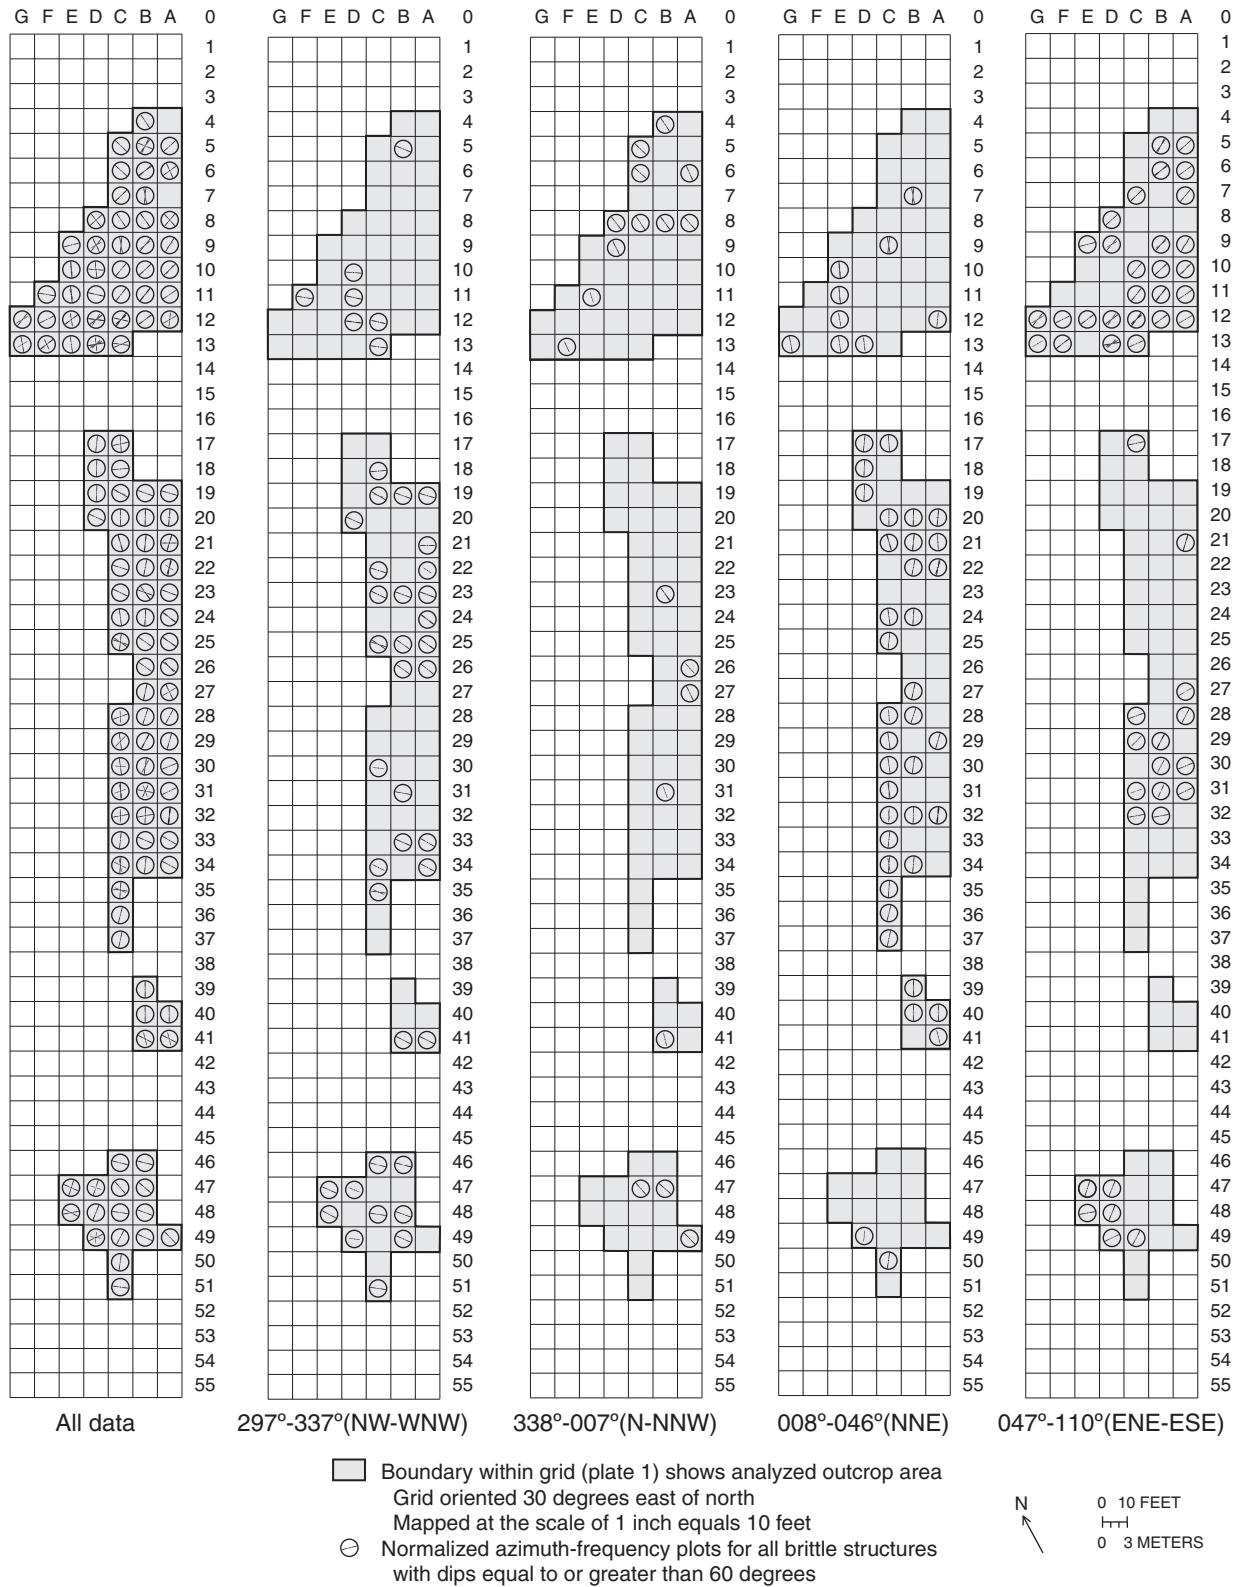
**Figure 15.** Cell-by-cell analysis of principal fracture trends at the cell-house site, Berlin, N.H. Grid shown on plate 1.

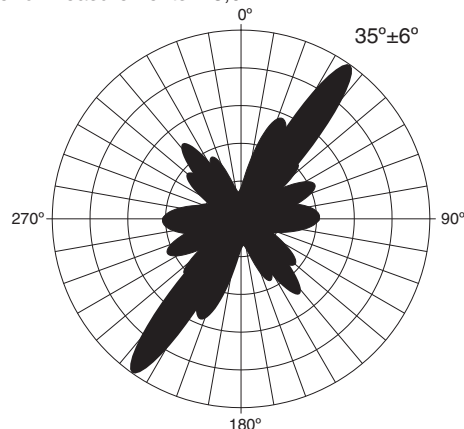
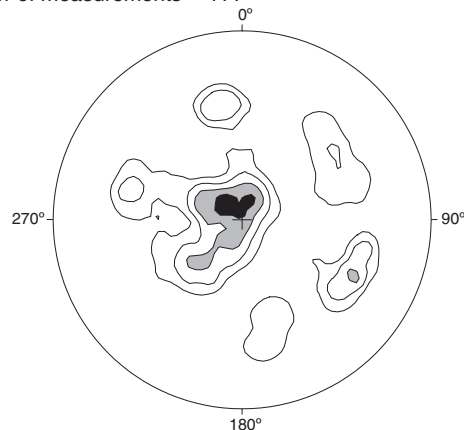
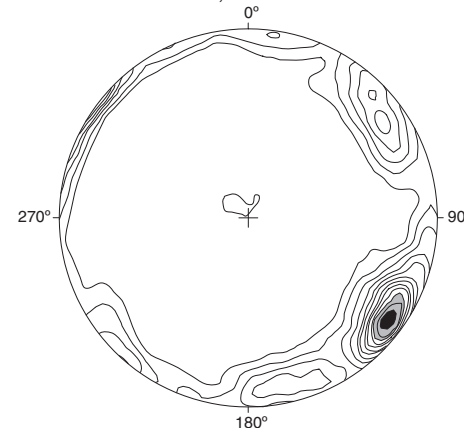
### A. Normalized azimuth-frequency plot for fractures dipping greater than 60 degrees

### B. Stereonet for fractures dipping less than 60 degrees

### C. Stereonet of all fractures

**Figure 16.** Orientation of all fractures at the cell-house site, Berlin, N.H. (A) normalized azimuth-frequency plot for steeply dipping fractures, (B) stereonet for fractures dipping less than 60°, and (C) stereonet of all fractures.

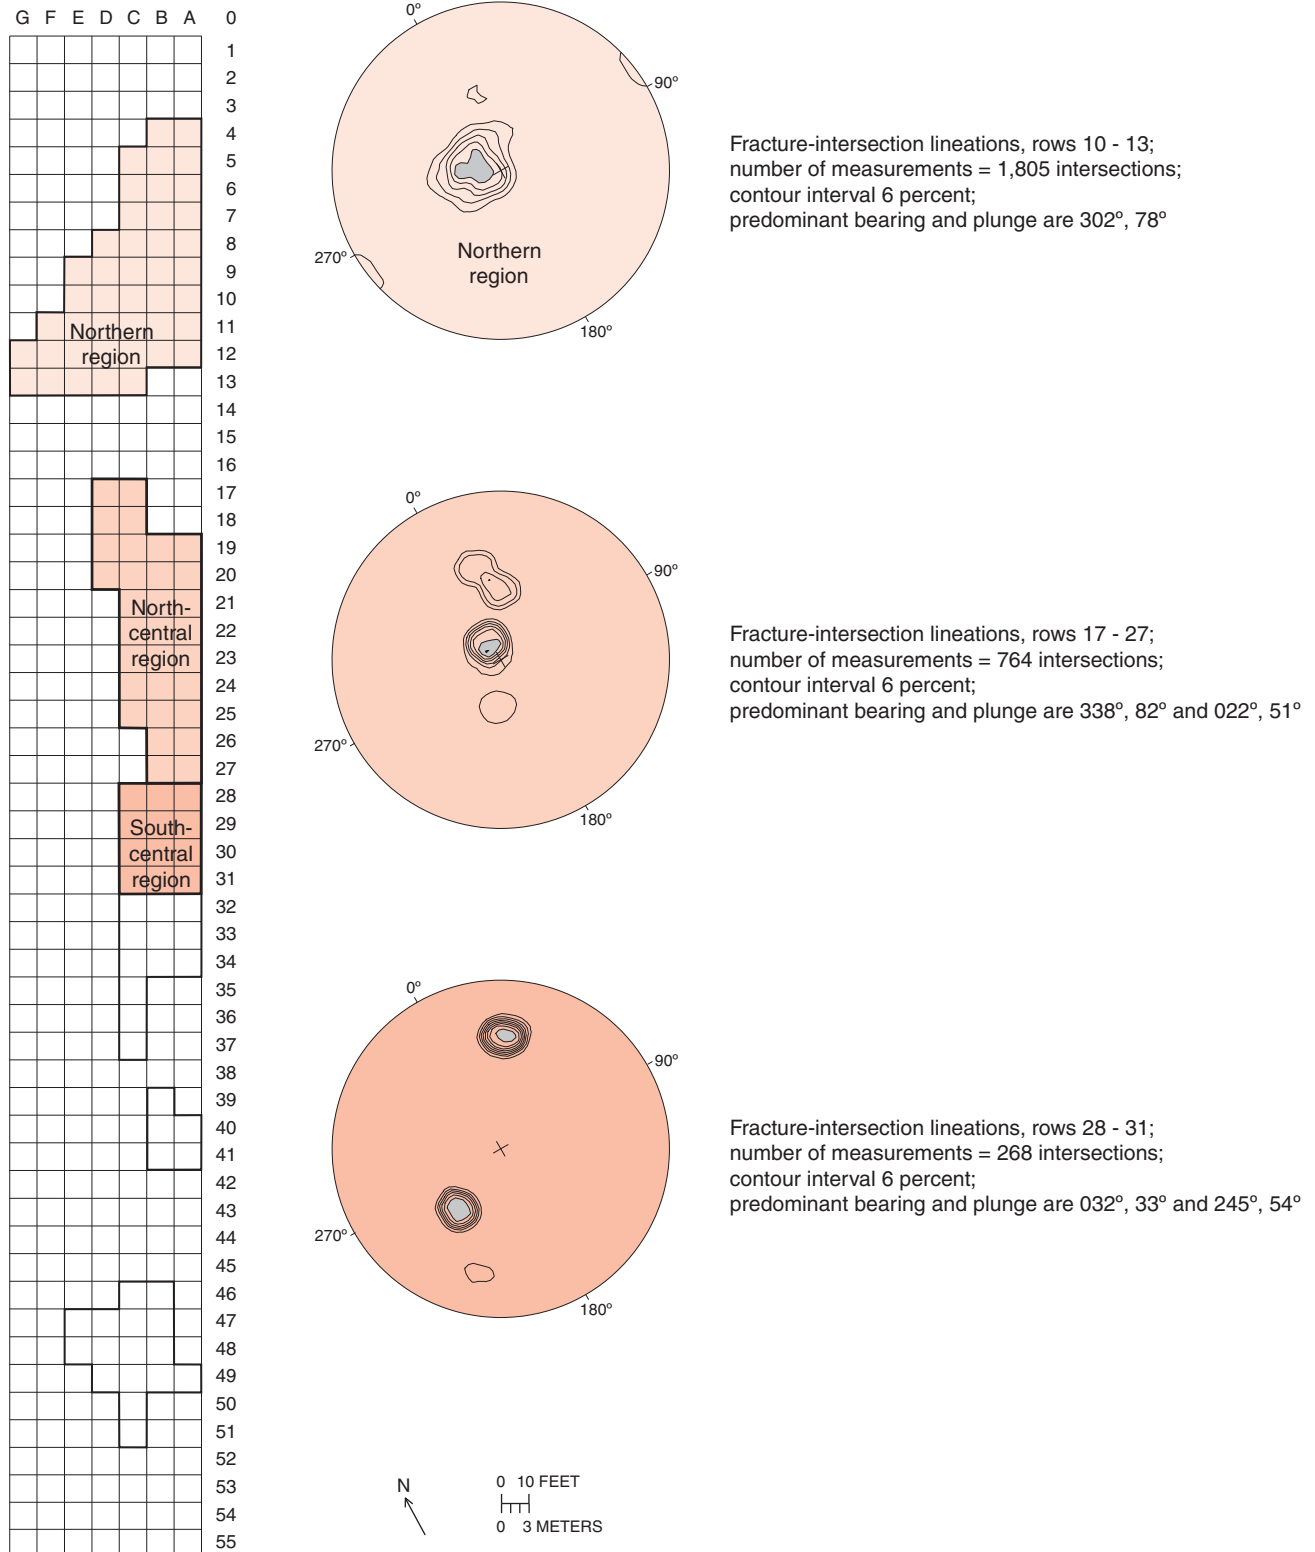
**Figure 17.** Stereonet plots of fracture-intersection lineations for the northern, north-central, and south-central regions of the riverbank at the cell-house site, Berlin, N.H. Grid shown on plate 1.

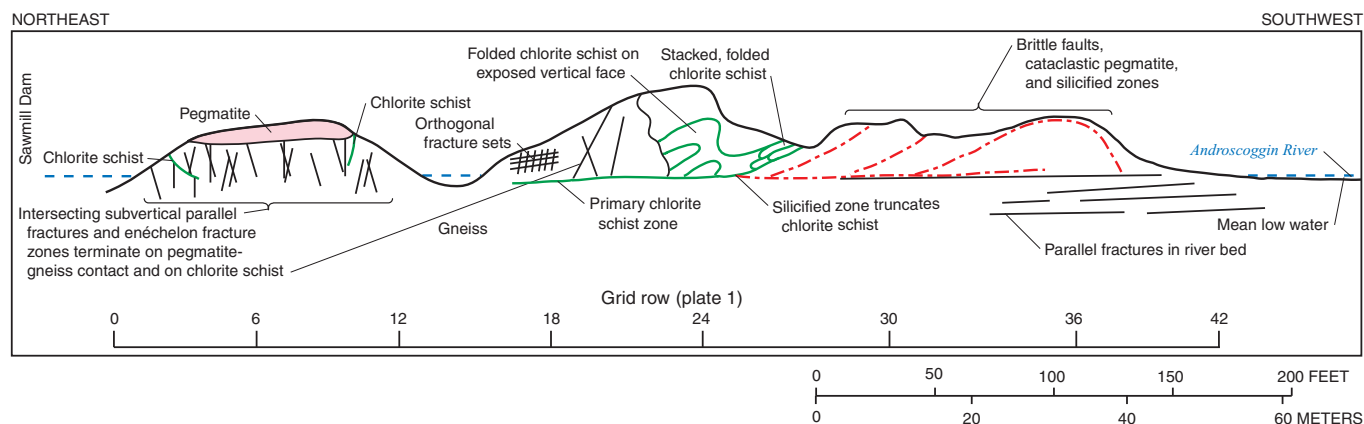
**Figure 18.** Generalized cross section of the bedrock geology at the cell-house site outcrop from grid 0 to 36, (360 feet) looking east, Berlin, N.H. Location shown on plate 1.

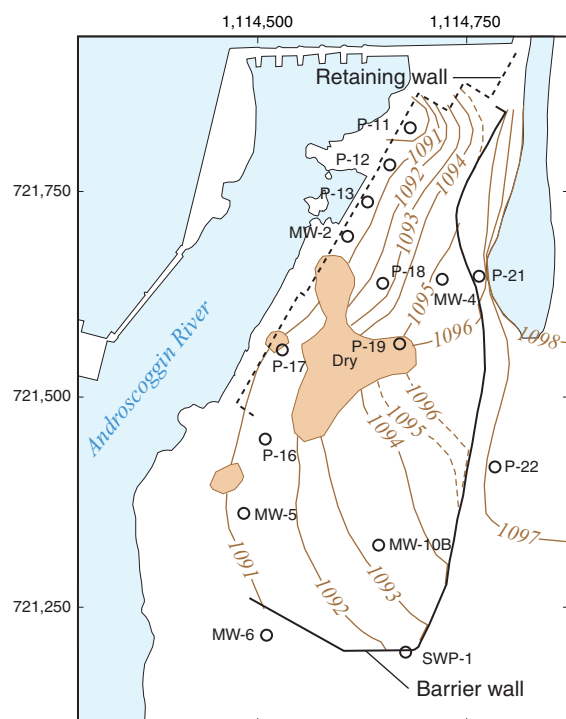
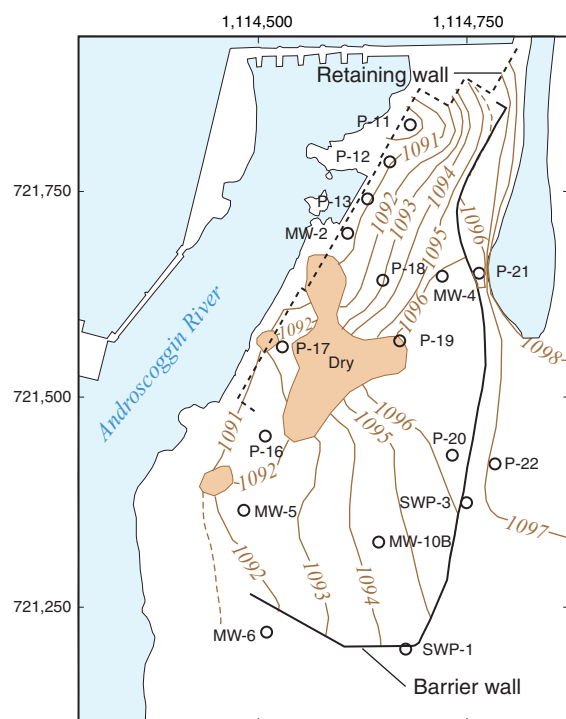
A. Low water-level conditions, March 20, 2003

B. High water-level conditions, April 2, 2003

A hydraulic head map constructed from overburden water levels on March 20, 2003 (fig. 19A), represents generally low water-level conditions and indicates a head difference of about 5 ft across the site. An unsaturated zone in the middle of the capped area (dry area on fig. 19A), caused by a high bedrock surface, separates flow in the overburden into a northern and southern area. The flow is to the west toward the river in both the northern and southern areas. A hydraulic-head map constructed from water levels on April 2, 2003 (fig. 19B), indicates a high water-level condition with a head gradient similar to the low water-level condition on March 20, 2003. Because overburden water-level fluctuations are small, head gradients in the overburden remain fairly constant across the cap area partly the result of the relatively stable head in the canal, and flow out of the discharge pipe in the concrete wall, in addition to the geomembrane cap on the site. The discharge pipe drains

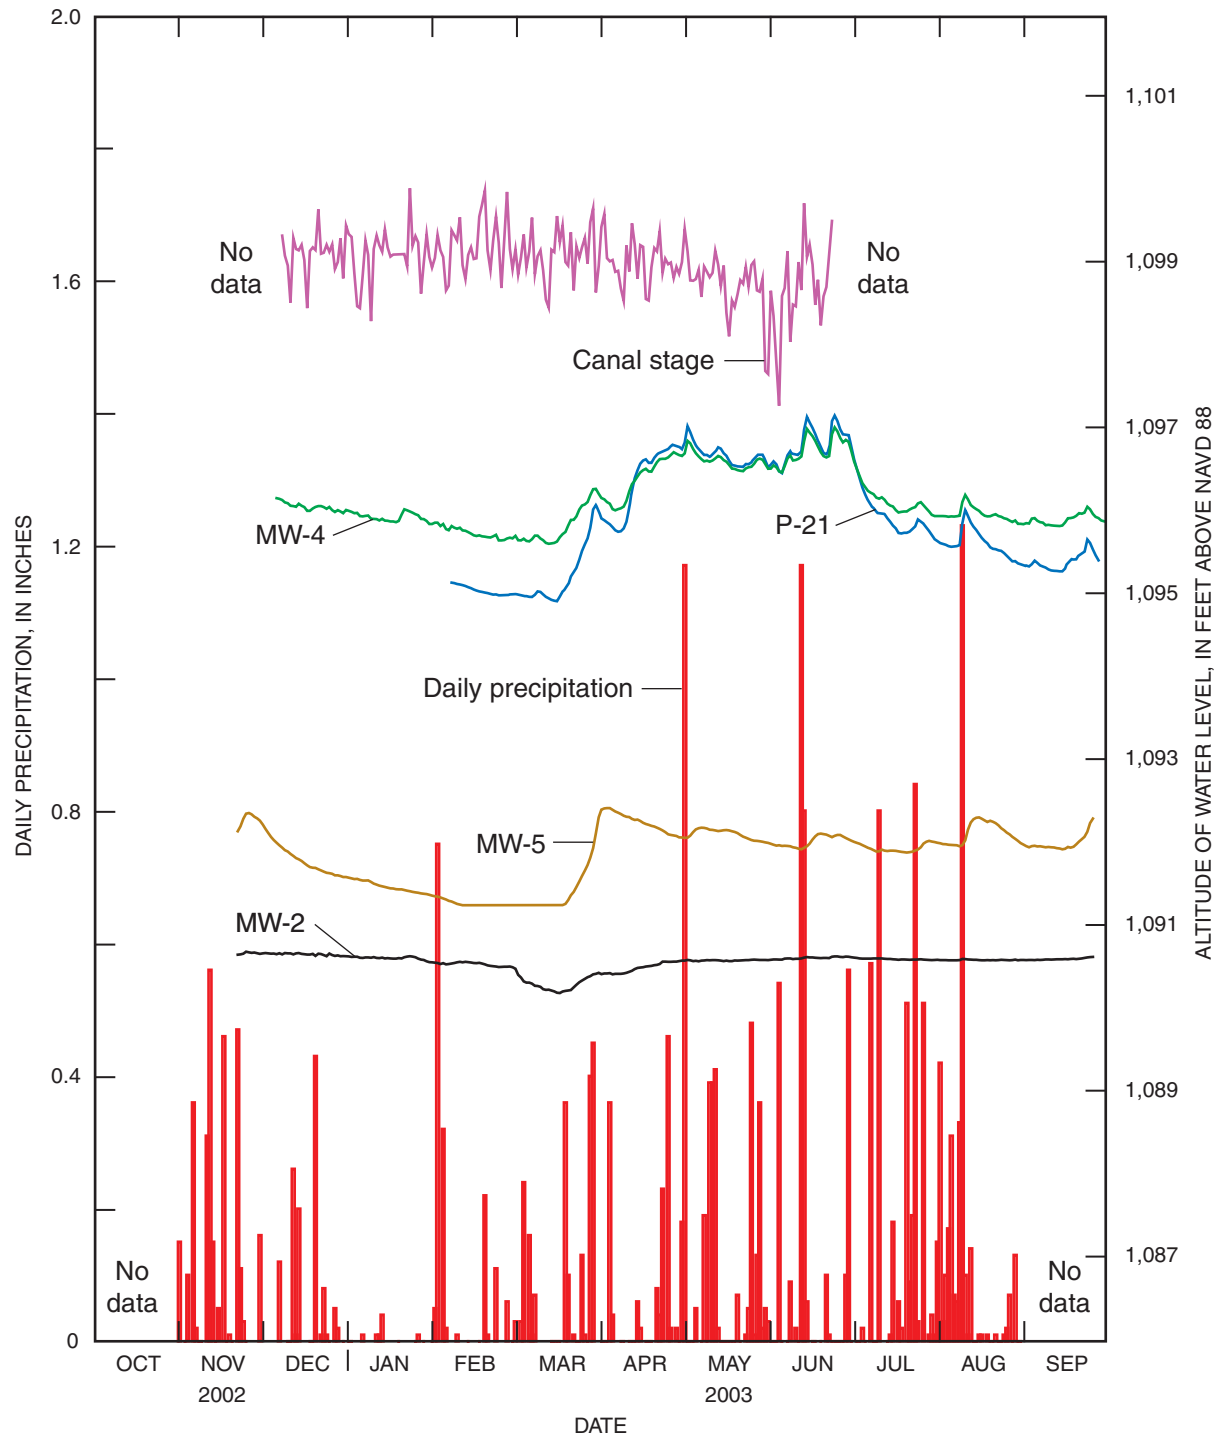
**Figure 21.** Daily precipitation and average daily water levels from overburden wells MW-2, MW-4, MW-5, P-21, and canal stage at the cell-house site, Berlin, N.H. (Location of wells shown on figure 2. Daily precipitation data from National Oceanic and Atmospheric Administration, 2003)
